# Above the Flood: Elevating Your Floodprone House

FEMA 347/ May 2000

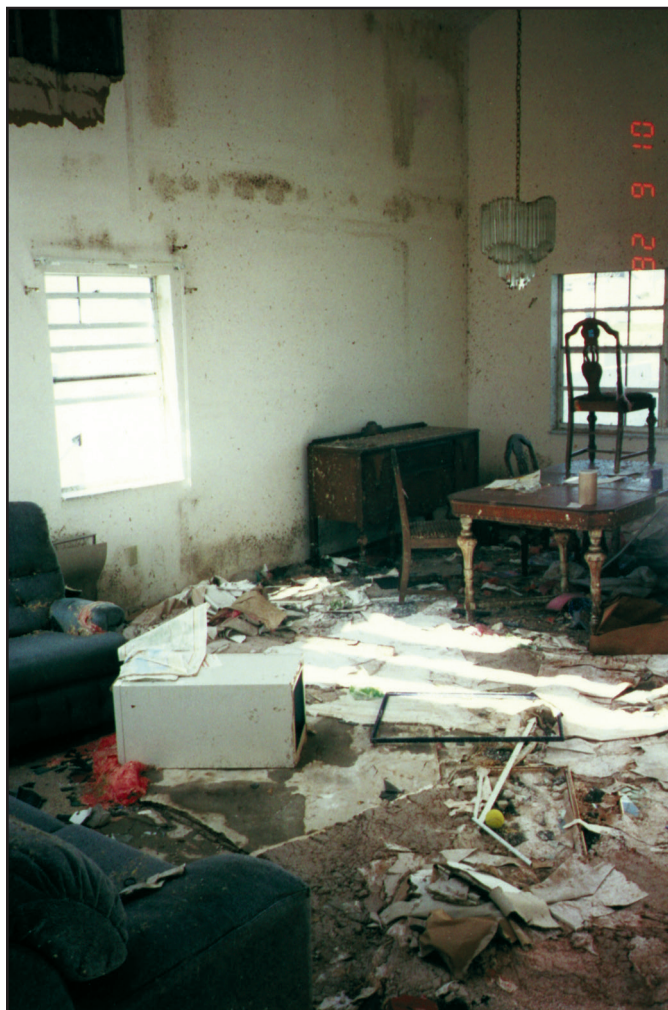
**Figure 4**

In low-lying areas, wind and rain damage to interior finishes and furnishings was exacerbated by flood waters.

The widespread destruction caused by Andrew was due primarily to high winds (Figure 3). However, flood waters contributed to the damage in low-lying coastal areas of central and southern Miami-Dade County (Figure 4).

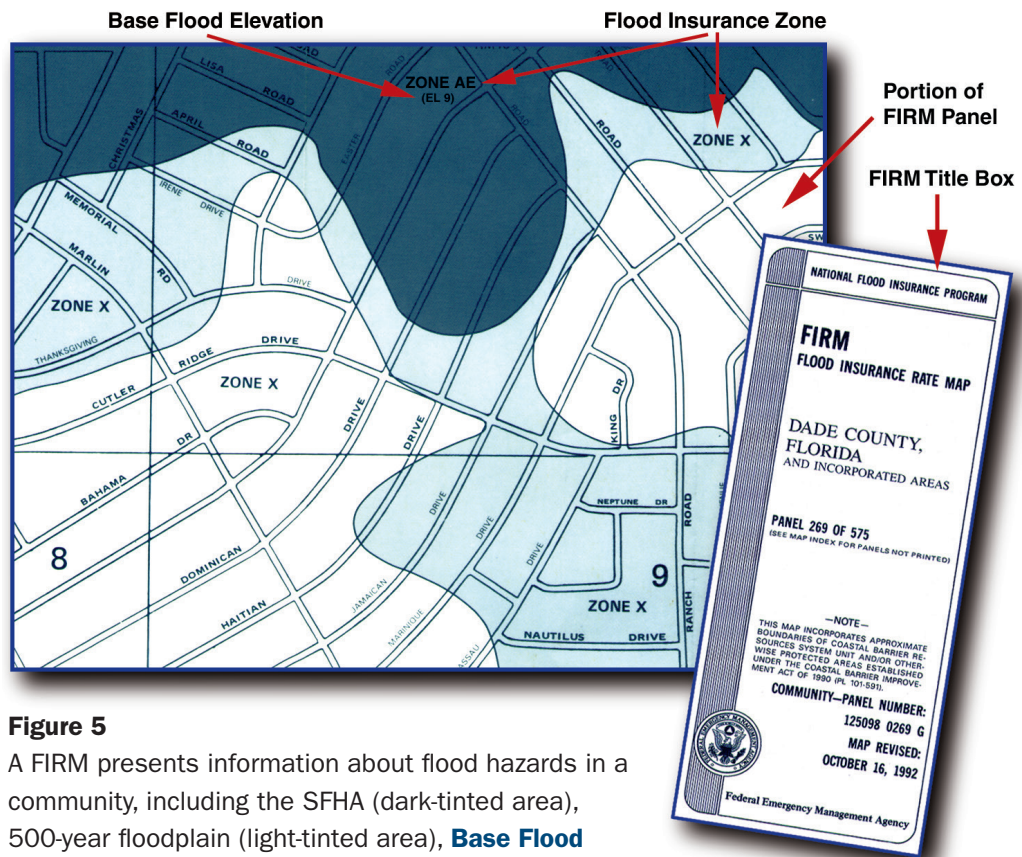
**Figure 5**

A FIRM presents information about flood hazards in a community, including the SFHA (dark-tinted area), 500-year floodplain (light-tinted area), **Base Flood Elevations**, (BFEs) (number in parentheses), and flood insurance zones (AE and X in this example).

Note that the SFHA in the example in Figure 5 is designated Zone AE. This zone is only one of several applied to SFHAs under the NFIP, including V, VE, V1-V30, A, AE, A1-A30, AO, and AH. These zones indicate differences in the types and severity of flood hazards in SFHAs. For the purposes of this publication, it is sufficient to focus on the basic differences between the two main types of SFHA zones—V zones and A zones. The distinction is important because regulatory requirements associated with V zones and A zones differ significantly. As explained later in this chapter, these requirements affect the types of building elevation techniques that may be used under the NFIP.

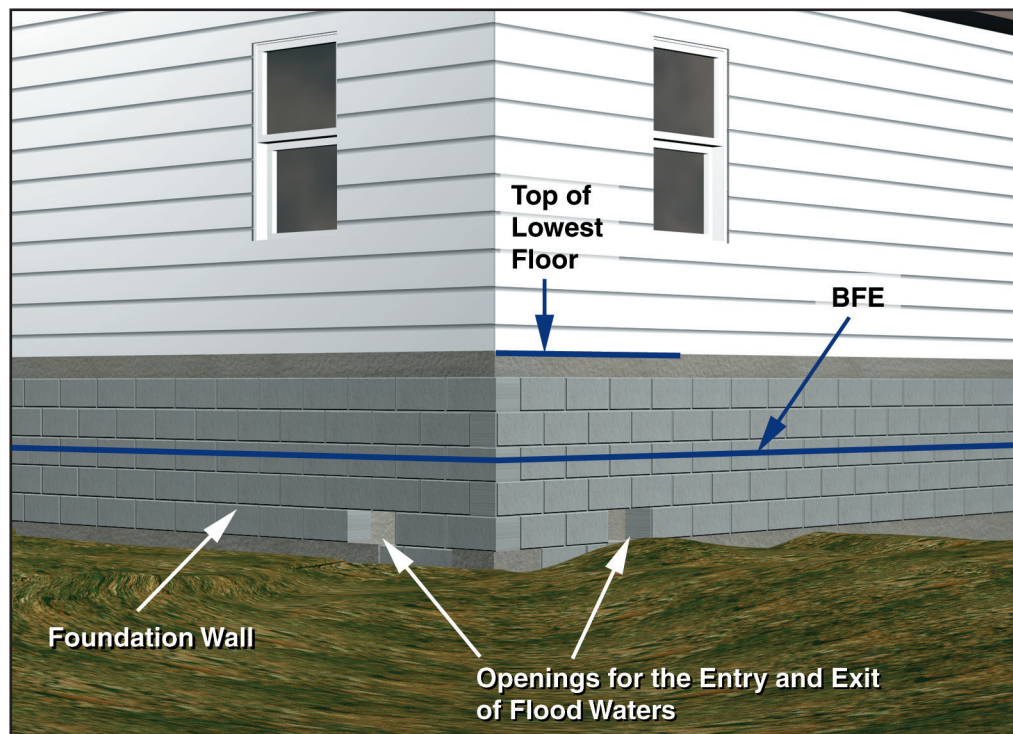
**Figure 6**

In a new, substantially improved, or substantially damaged building in an A zone, the elevation of the lowest floor must be at or above the BFE.

In A zones, where flood hazards are less severe, buildings may be elevated either on an open foundation or on continuous foundation walls below the BFE (Figure 6). Regardless of the type of foundation used, A-zone buildings must be elevated so that the **lowest floor** is at or above the BFE, as shown in Figure 6. If continuous walls are used below the BFE, they must be equipped with openings that allow flood waters to flow into and out of the area enclosed by the walls (Figure 6). Allowing the entry and exit of flood waters ensures that water pressures will be the same on both sides of the walls and reduces the likelihood that water pressure will cause the walls to fail.

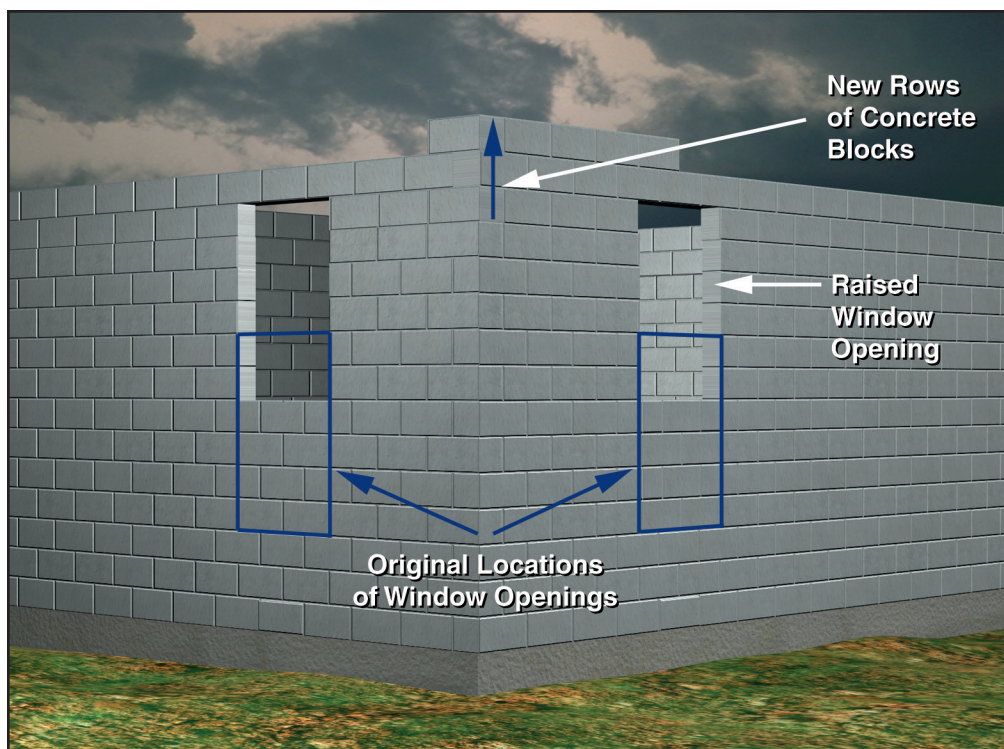
The tops of the walls and bottoms of the window openings are raised with concrete blocks.

After the roof, windows, and doors are removed, several courses of concrete block are added to the tops of the existing walls and to the bottoms of the window openings (Figure 11). A corresponding number of blocks are removed from the tops of the window openings so that the size of the windows will remain the same. In addition, although not shown in Figure 11, concrete bond beams are formed in place at the tops of the extended walls to provide structural reinforcement.

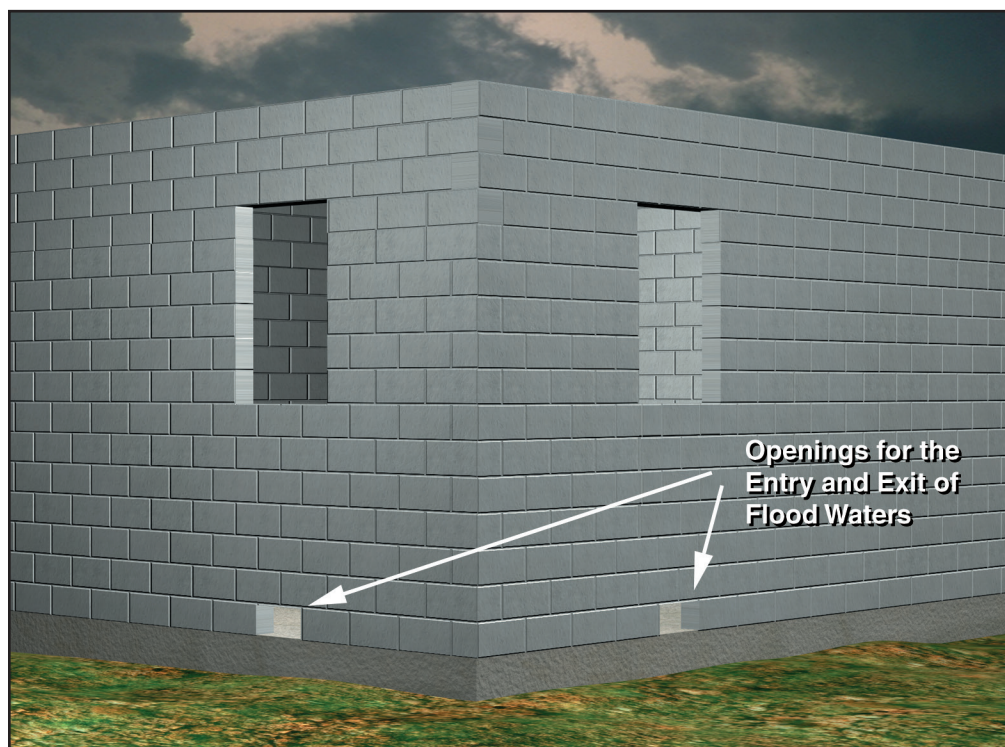
**Figure 12**  
Openings are created  
in the walls near the  
ground.

Blocks are removed from the walls of the house at selected locations within 1 foot of the ground (Figure 12). The resulting openings will allow flood waters to flow into and out of the lower area of the house so that the water pressures on both sides of the walls will remain the same. The roof and windows are then replaced, and a new wood-frame floor is constructed above the flood level (Figure 13).

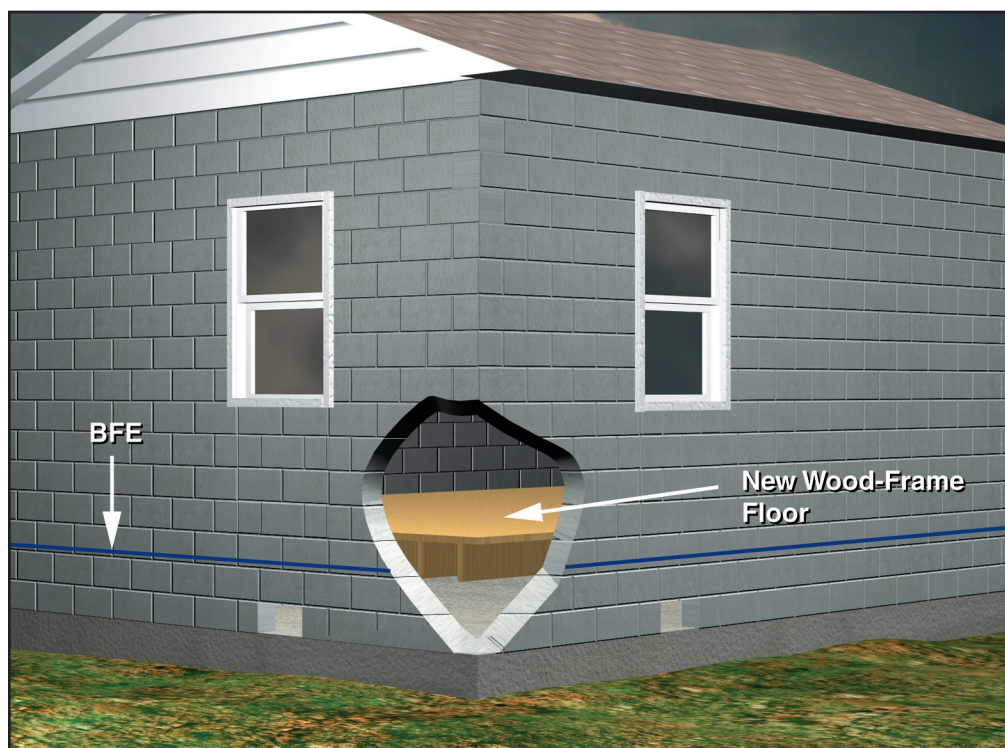
**Figure 13**  
A new wood-frame  
lowest floor is  
constructed above the  
flood level, and the  
roof, windows, and  
doors are reinstalled.

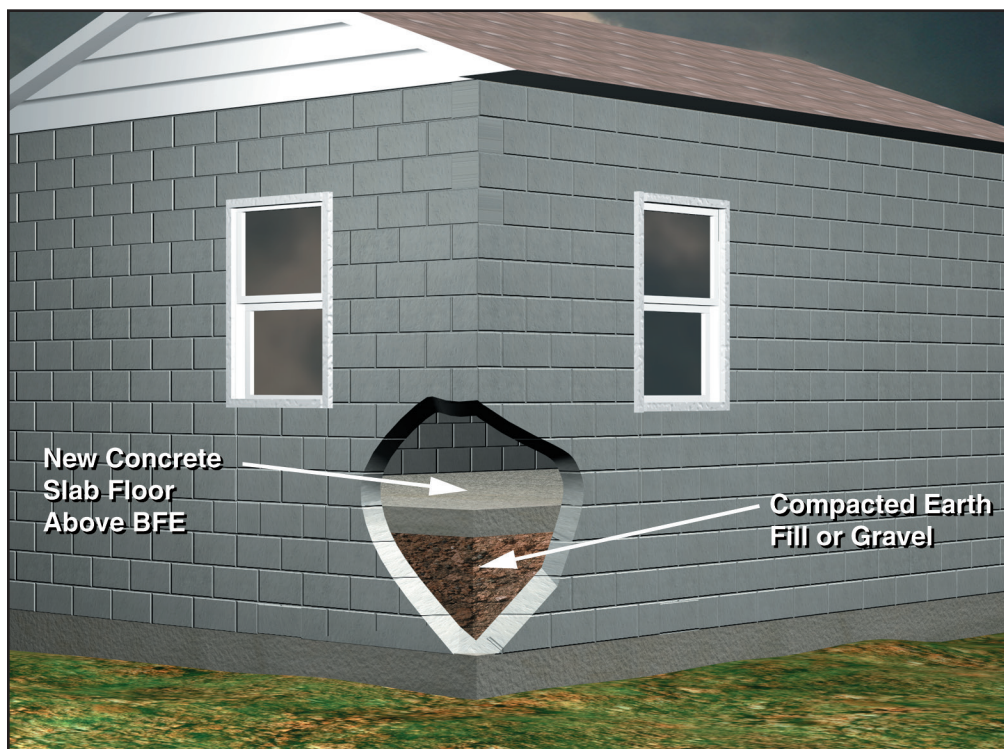
**Figure 14**  
An alternative to building an elevated wood-frame floor is installing a new, elevated concrete slab floor on fill placed over the old slab.

A homeowner who chooses Technique 1 may decide to build a new concrete slab floor instead of a wood floor (Figure 14). When this option is chosen, compacted fill dirt or gravel is placed on top of the old slab and the new slab floor is poured on top. Because the area below the new floor is filled with dirt or gravel, wall openings are not required.

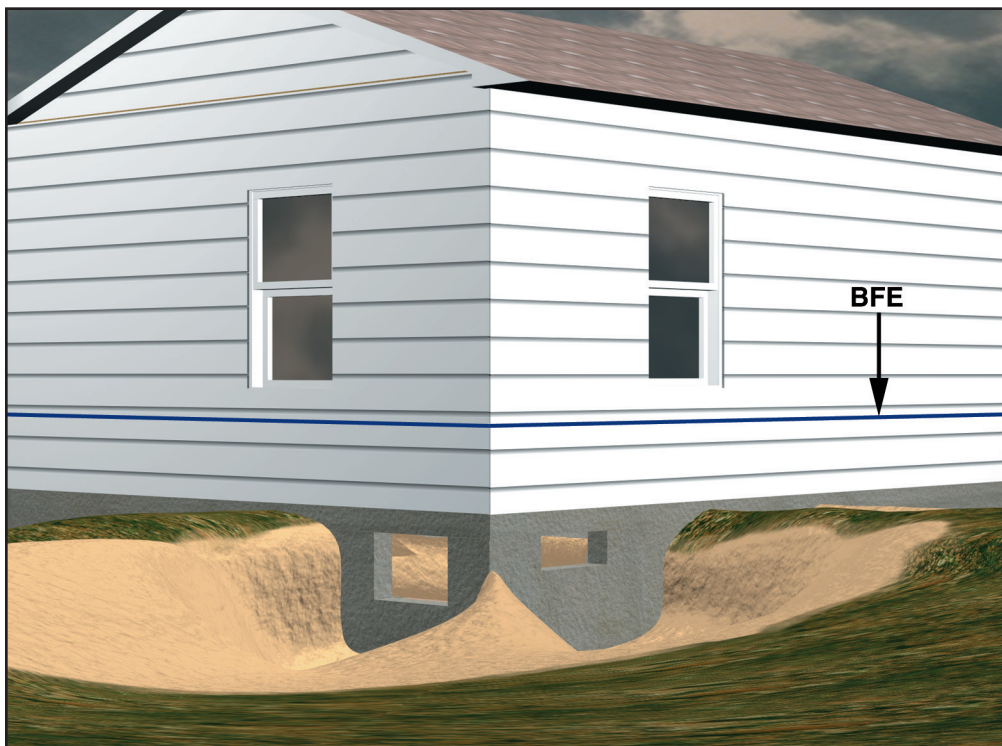
**Figure 17**  
Trenches and tunnels under the slab provide access for the jacks and I-beams that will lift the house.

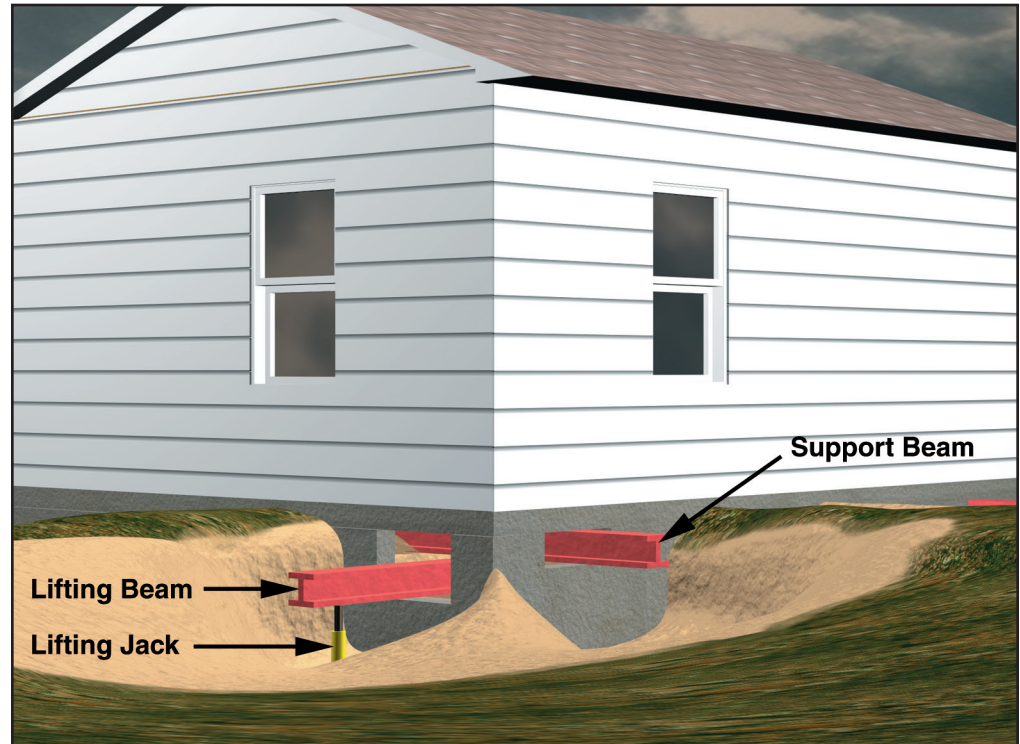
**Figure 18**  
With I-beams and jacks in place, the house is ready to be lifted.

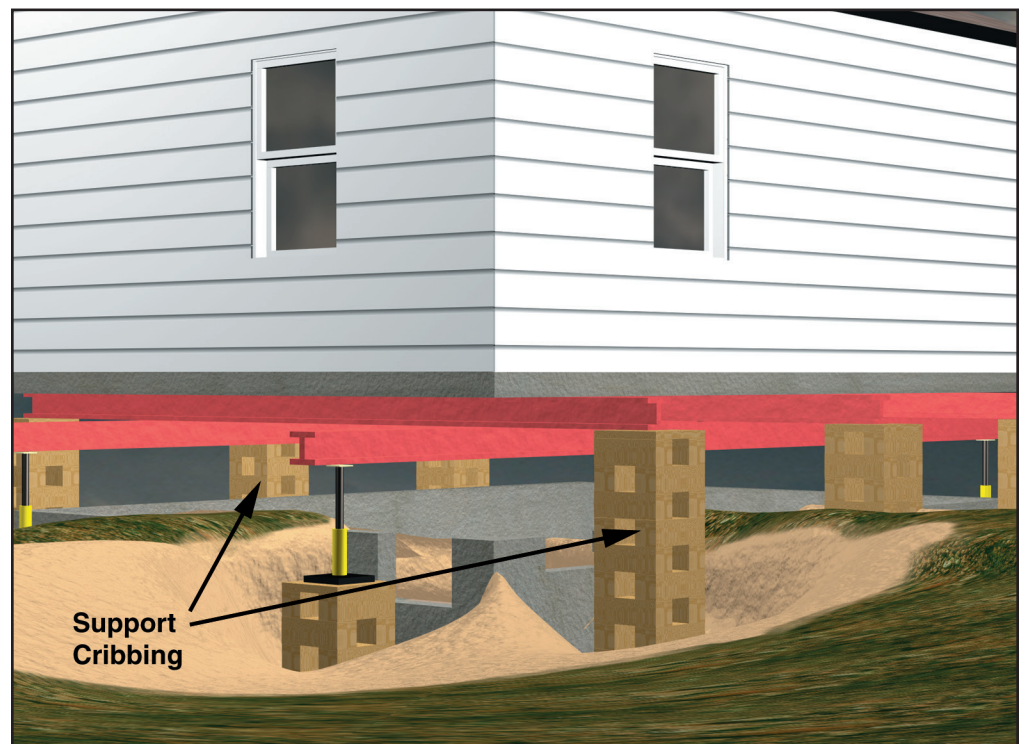
**Figure 19**  
The house is temporarily supported on cribbing.

The house is then jacked up. When the jacks have extended as far as possible, the house must be supported temporarily while the jacks are raised. Both the house and the jacks are usually supported on “cribbing”—temporary piles of crisscrossed timbers (Figure 19). The jacks are then used to raise the house higher.

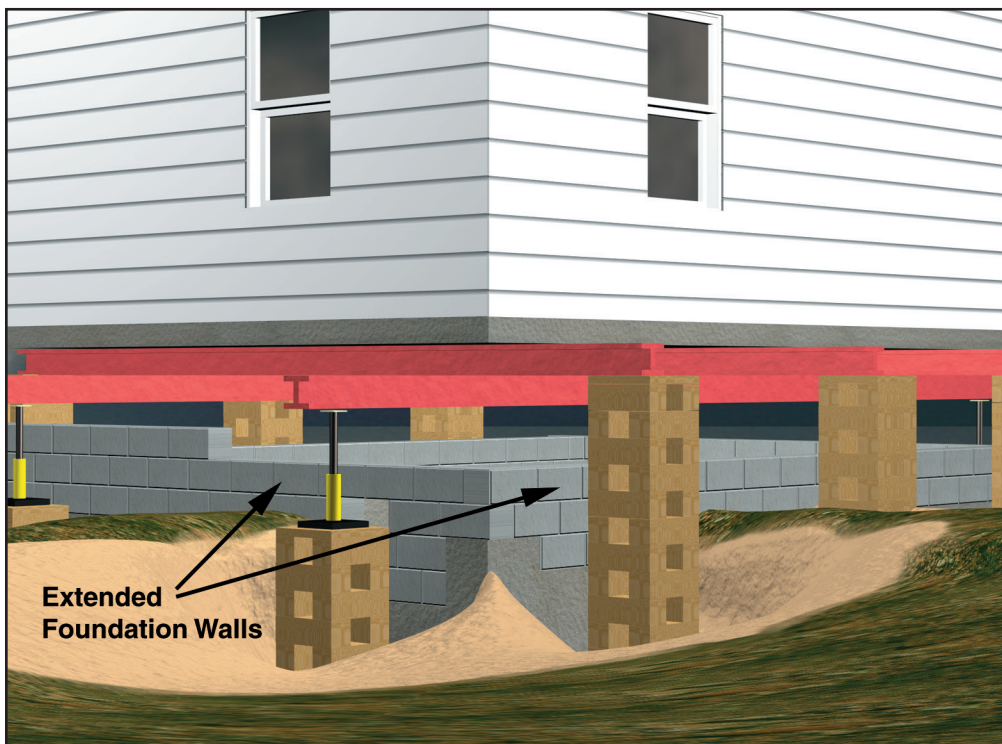
**Figure 20**  
New, extended  
foundation walls are  
constructed with  
concrete blocks.

This process is repeated until the house is raised to the desired height. The foundation walls are then extended upward with additional rows of concrete block (Figure 20). As in the previous techniques, openings are made in the walls within 1 foot of the ground so that flood waters will be able to flow into and out of the area below the elevated floor. The jacks and beams are removed, and the openings left around the beams are filled with blocks (Figure 21).

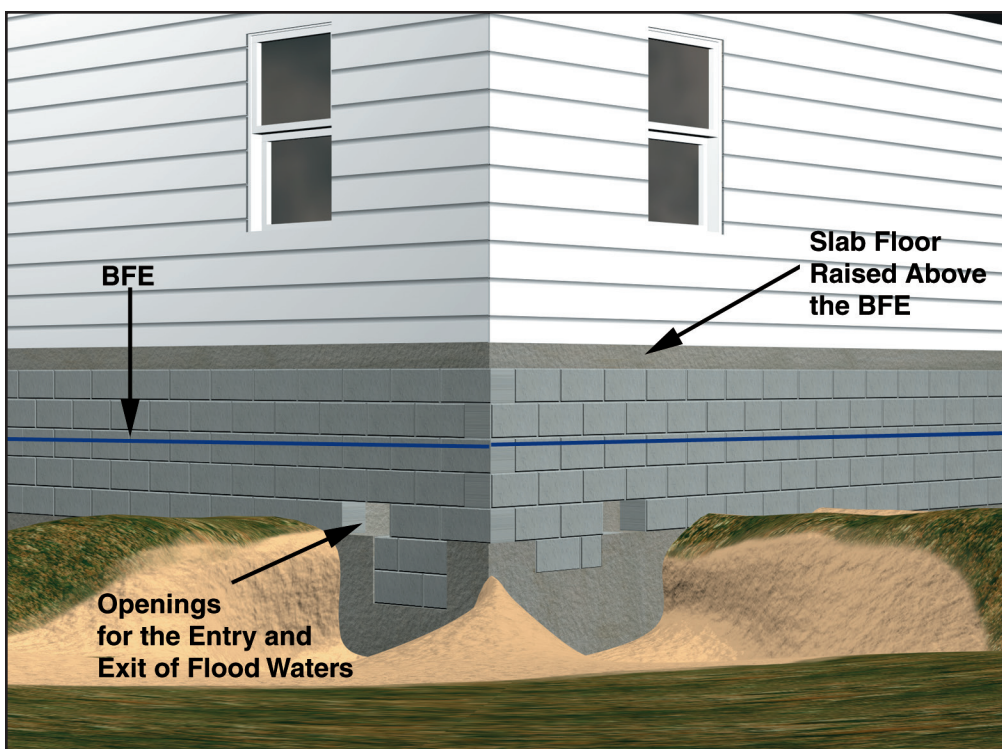
**Figure 21**  
Elevated house and  
slab on new, extended  
foundation walls.

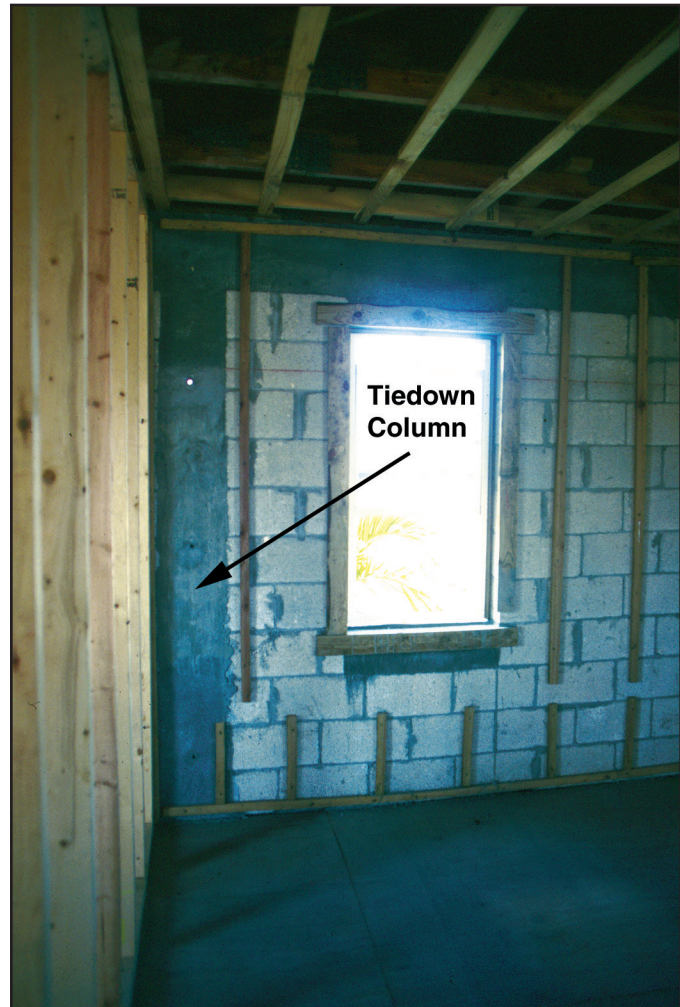
**Figure 46**  
Concrete tiedown columns, such as the one to the left of the window in this photograph, were also used in this house.

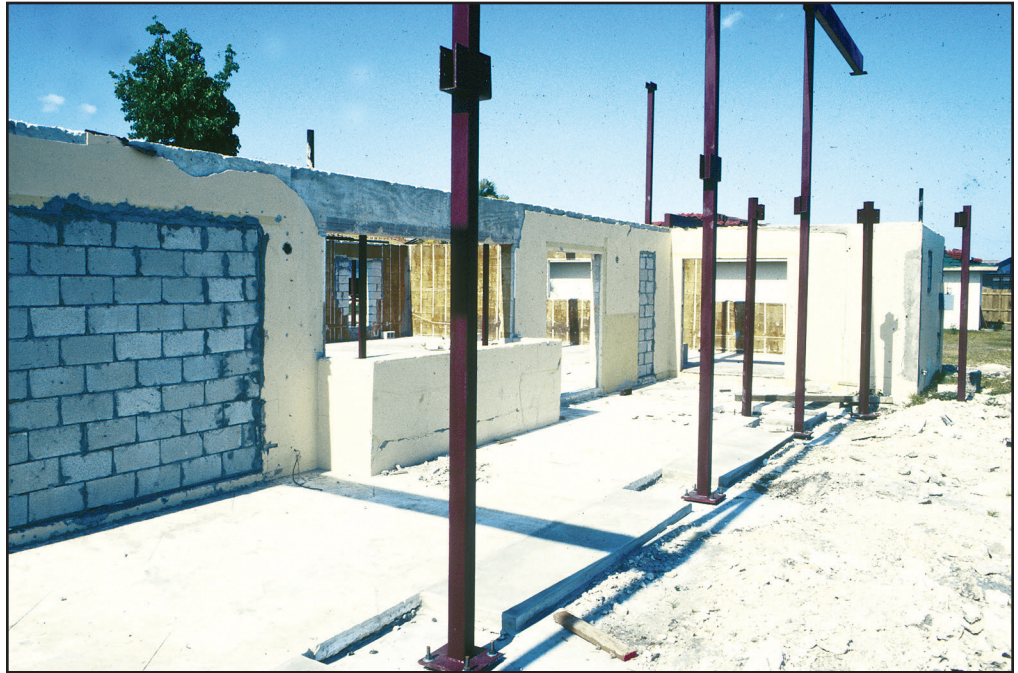
**Figure 52**

The existing first-story walls have been strengthened by the addition of concrete block. Metal columns and beams have been added to help support the new second story.

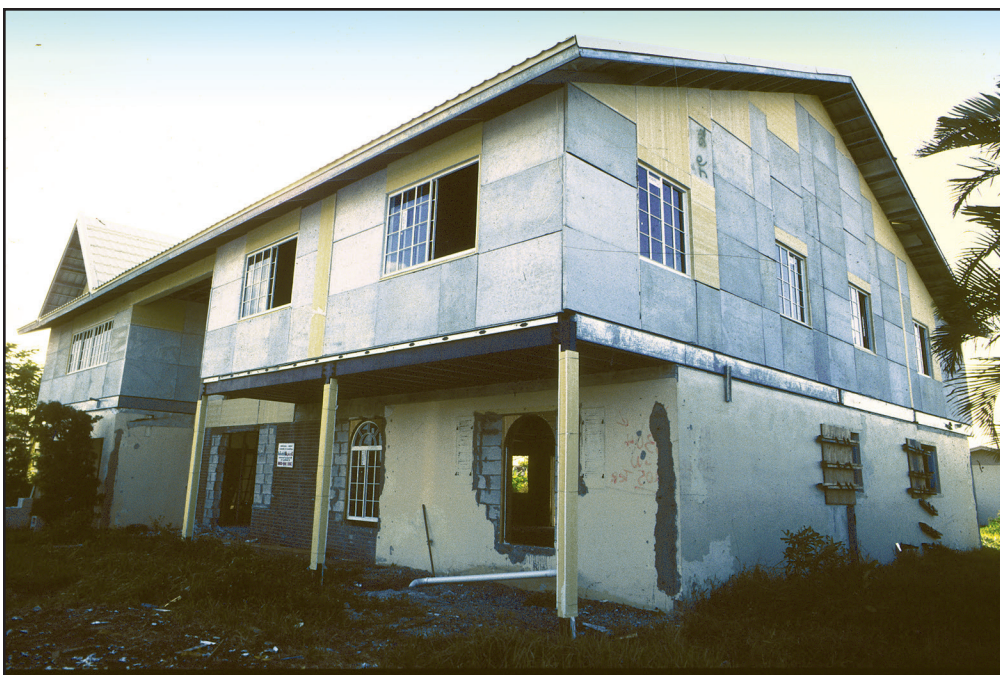
**Figure 59**

The exterior  
walls consist of  
prefabricated  
concrete panels.  
Innovative techniques  
such as those  
employed in this  
project are helping  
homeowners who  
need practical and  
economical methods  
of repairing and  
protecting their  
houses.
